# Big Dipper® solves drainage problems at high profile pub and bar

**Site:** Prestigious Restaurant, Mailbox Birmingham  
**Client:** xxxxxx  
**Problem:** Grease problems in pump station

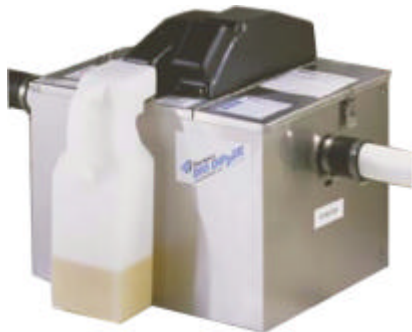
The unit which removes over 95% of fat, oil and grease was installed underneath the potwash sink.

From here the unit intercepts the fat, oil and grease carried in the potwash effluent. Then twice a day the Big Dipper® automatically discharges the intercepted oil into an external container for disposal.

Watling Hope proposed to install a Big Dipper® WS-200 automatic grease interceptor.

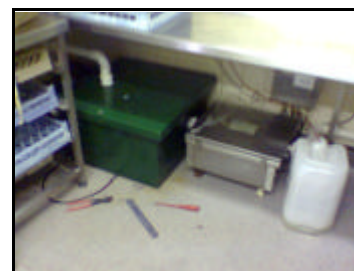
Despite the presence of a basket type grease trap the pump unit was routinely clogging with grease which was causing unpleasant odours and flooding onto the kitchen floor.

Before installation

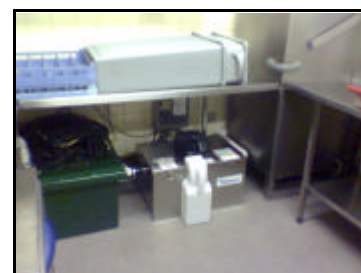
After installation

- No pump failure since installation
  - No flooding since installation
  - No grease in line since installation
-
